**YCCART 2010/Y25
North Somerset HER 2010-113**

The Old Stone Crosses of Congresbury: historical and photographic study

**YATTON, CONGRESBURY, CLAVERHAM AND CLEEVE ARCHAEOLOGICAL RESEARCH
TEAM (YCCART)**

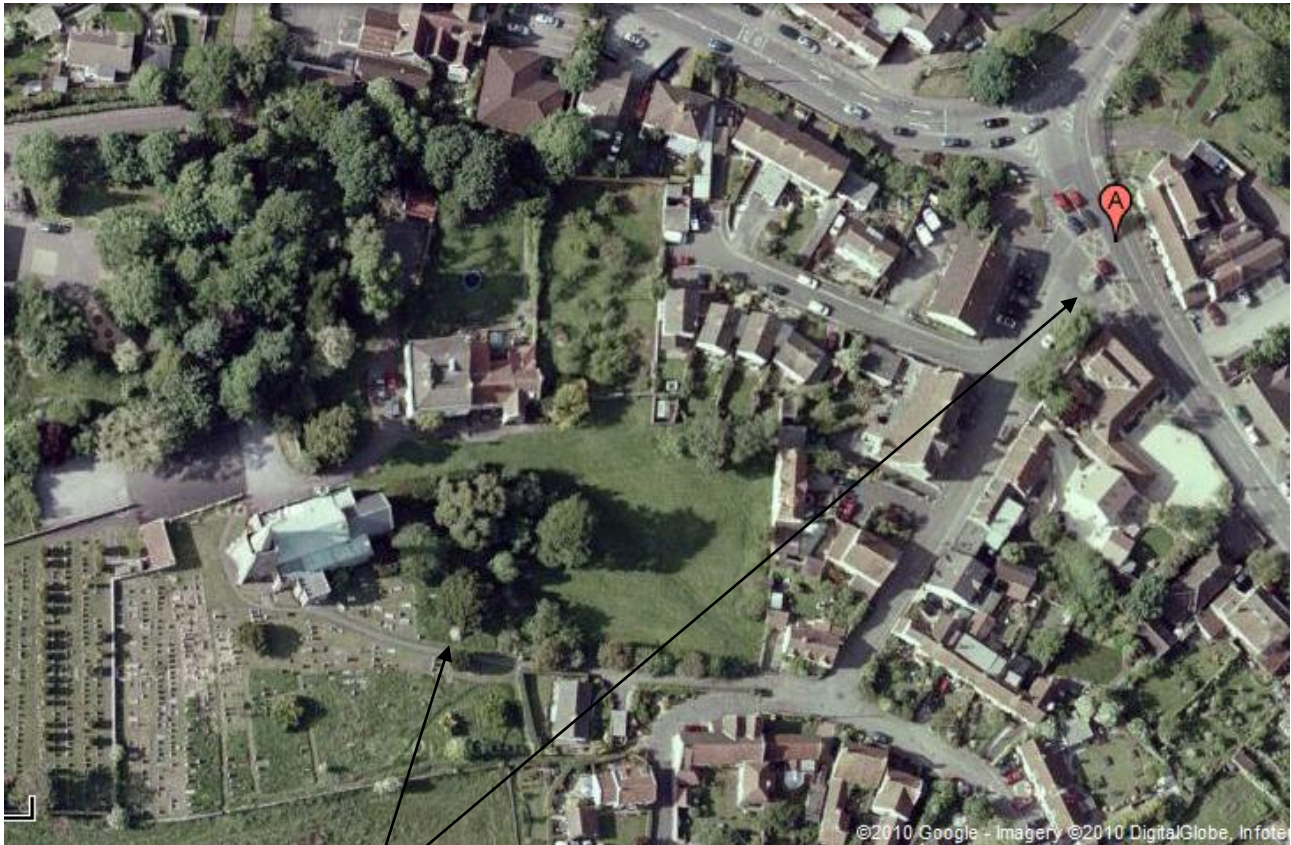
Fig 1: Locations of Congresbury churchyard (to west) and village (east) crosses

Congresbury churchyard cross lies in the churchyard of St Andrew's parish church, 25m SE of the corner of the south aisle chapel of the church, at ST43606374. The village cross stands at the junction of Broad Street and High Street, at ST43736381. Both are in the village of Congresbury in North Somerset, some 15km SW of the city of Bristol.

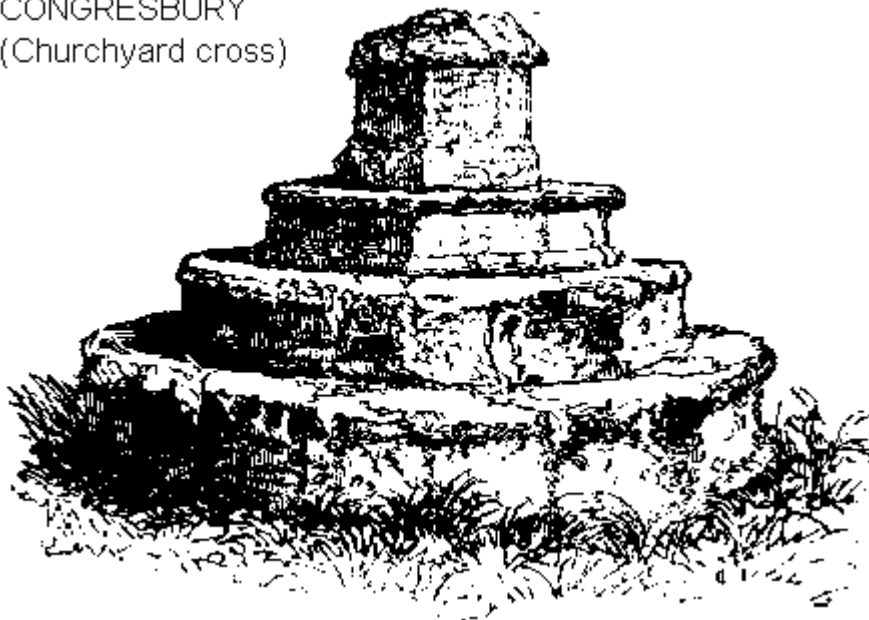
CONGRESBURY
(Churchyard cross)

The churchyard cross is a fine specimen of fourteenth century work. Two stages of it only are preserved - the steps, which are three in number, octagonal, and with sunk facings and weather-drip mouldings and splays; and the socket, which is an equal-sided octagon, with deep drip and a set-off at base. It stands east of the south porch of the church.

The basement measures 4 ft. each face, by 1 ft. 7 in. in height; the second step, 2 ft. 9 in. each face, by 1 ft. 1 in. in height; and the third, 2 ft. each face, by 1 ft. in height. The socket is 2 ft. 5 in. in height, and 2 ft. 10 in. square at base. (Pooley 1877)

Fig 2: Congresbury churchyard cross (from Pooley 1877)

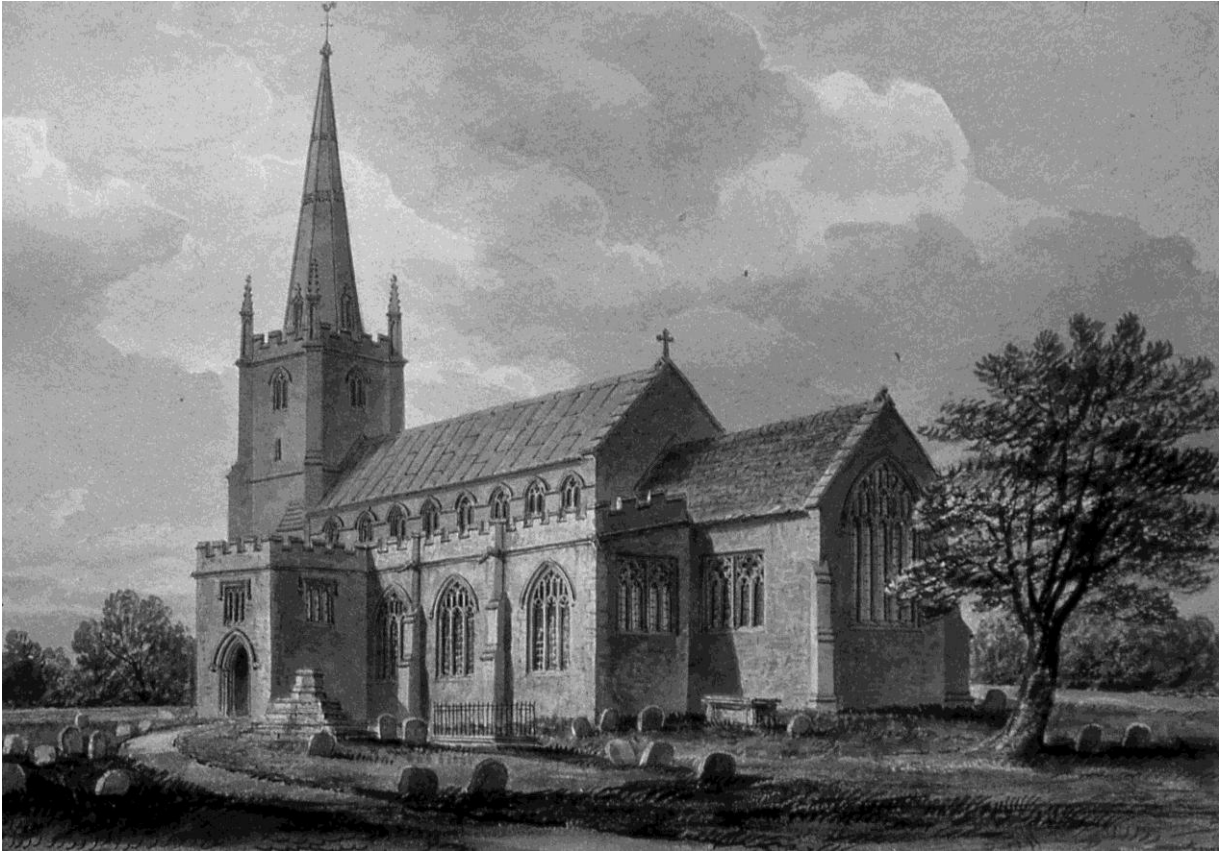
The cross has deteriorated since Pooley's day, despite being declared a Scheduled Monument (Avon 19). In 1974, apart from this, it looked exactly as Pooley had portrayed it. Although Rutter (1829) does not describe this cross, he does depict it with no less than five steps, although it is not certain how accurate his drawing is (Rutter 1829: 35). The earliest known depictions of this cross were in 1827, and are to be found in the Piggott collection in the library of the Somerset Archaeological and Natural History Society (Fig 3 below; cover artwork)

Fig 3: Churchyard cross and church, Congresbury (Piggott collection 1827)

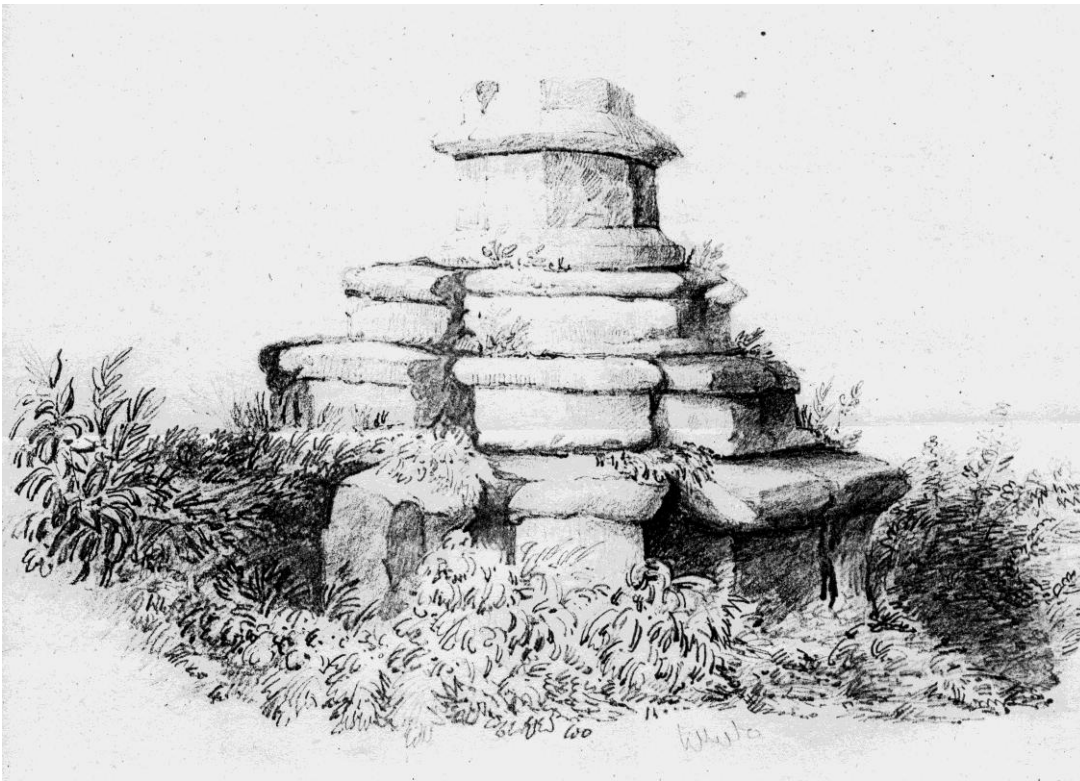
A slightly later (and far more accurate) drawing of the 1840s (Braikenridge 1840x1850 – Fig 4 below) shows the cross in a dilapidated and overgrown state, with large gaps between the stones, but otherwise much as in Pooley, with the possible exception of detail of the top of the socket, where the earlier drawing appears to show an octagonal section above the string which now forms the top of the socket. The cross is certainly in the same position as today, and was missing its shaft as early as that date. There must presumably have been a restoration between 1840 and the

Fig 4: Churchyard cross in 1840 – 50 (Braikenridge collection)

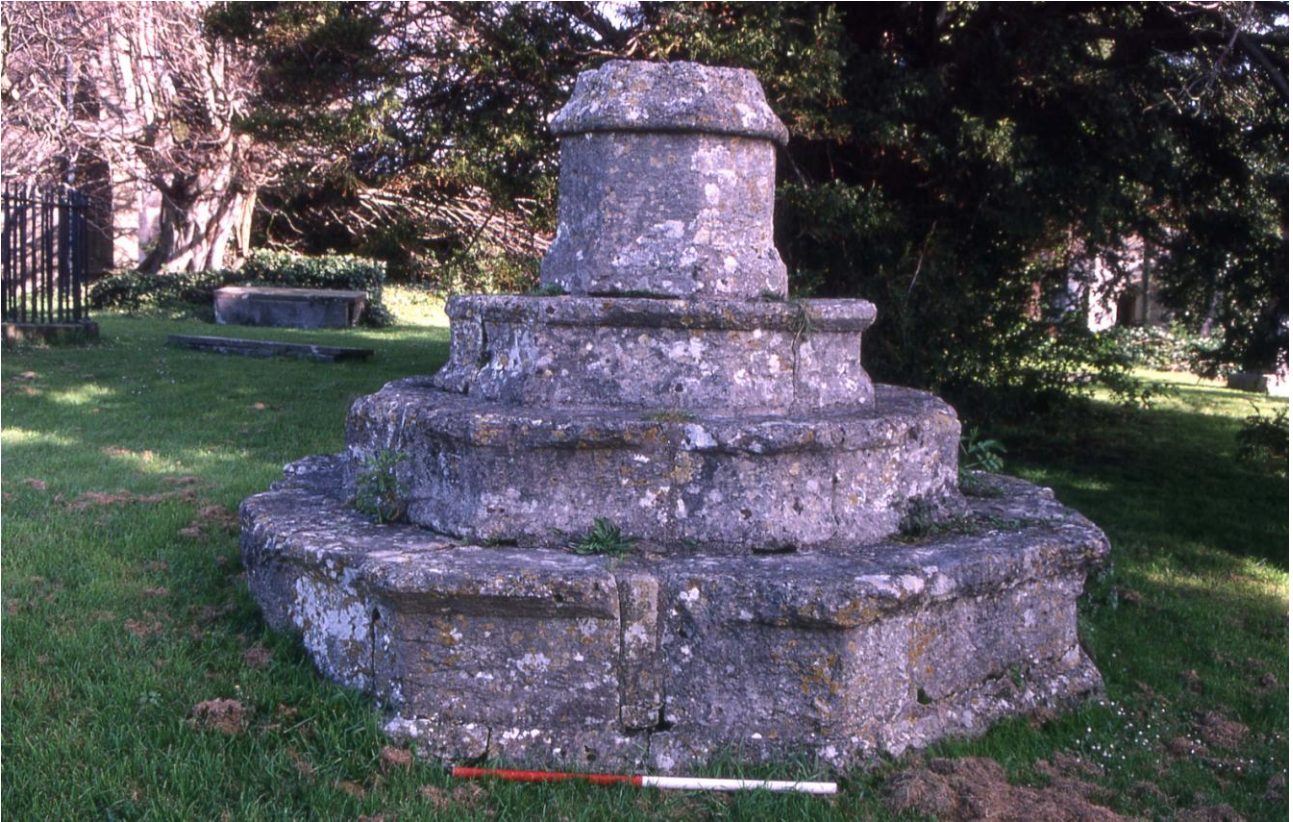
The top of the socket is unusual, in that it has a large square shallow recess in it, rather than a traditional socket. How this fitted a shaft is not clear, although it may have been that the stone recorded in Braikenridge and now not in place was that carrying the shaft mortise.

The adjacent yew tree has grown over and around the cross since 1974, and there is some argument for trimming it back to avoid damage to the stone.

Fig 5: Churchyard cross in 1994 (Vince Russett 1994) (scale = 1.0m)

There are no traces of iron fittings or drill holes in the steps or socket of the cross, but these may have been removed during uninformed 'restorations' since the medieval period.

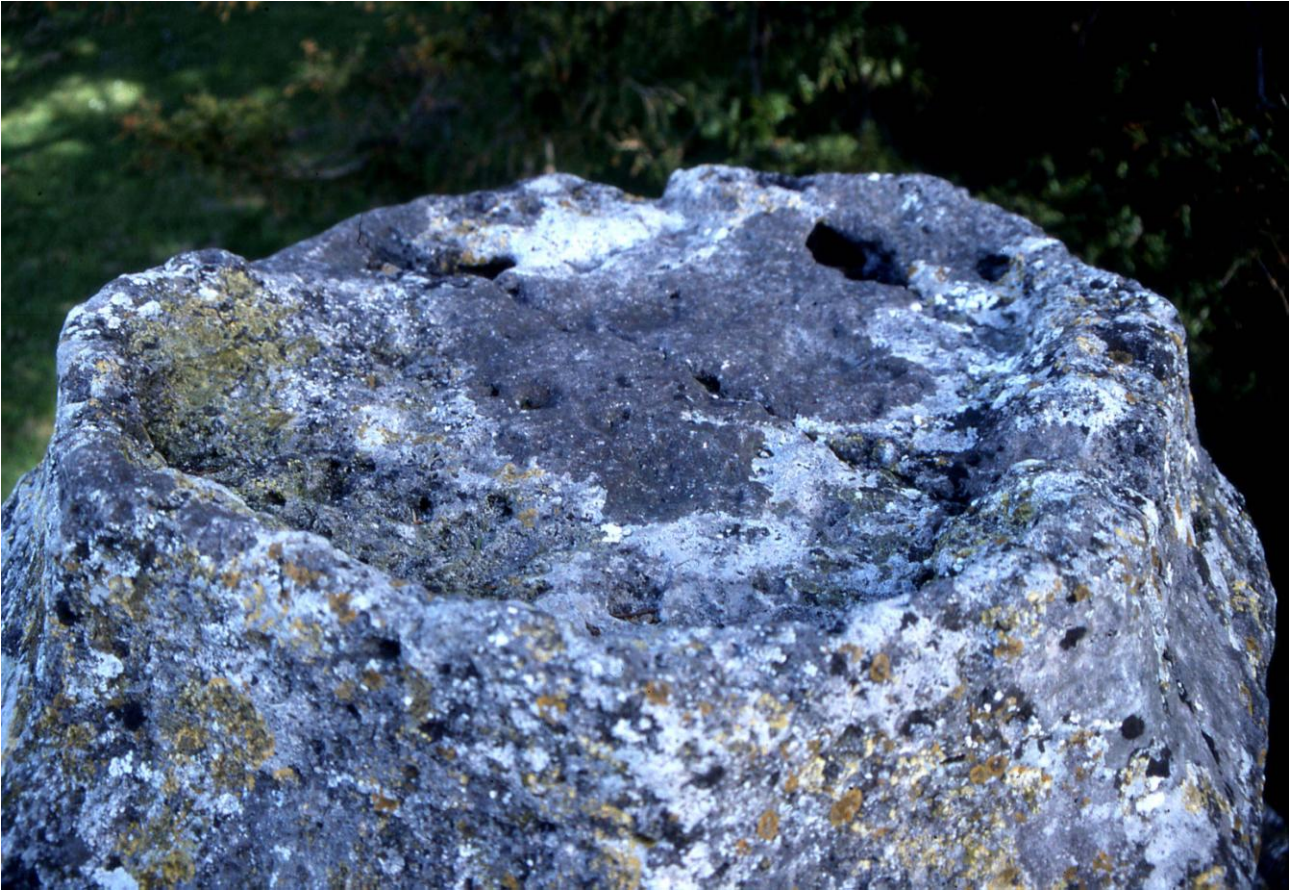
The hollow top to the socket is (Fig 6 below), as far as I am aware, unique: all other sockets have either a shaft, the remains of one, or a deep mortise for a shaft, either round (rarely) or square (usually) in section. Quite how the Congresbury cross socket functioned is unclear. It is, of course, possible that the socket has been hollowed out for some purpose after the shaft was demolished: in many areas, there is folklore based around the sockets being filled with vinegar to disinfect coins during trade at a time of plague – this could even reflect alteration of the top of the socket because of knowledge of, or even belief in, such tales.

Fig 6: The unusual hollow top to socket of churchyard cross (Vince Russett 1994)

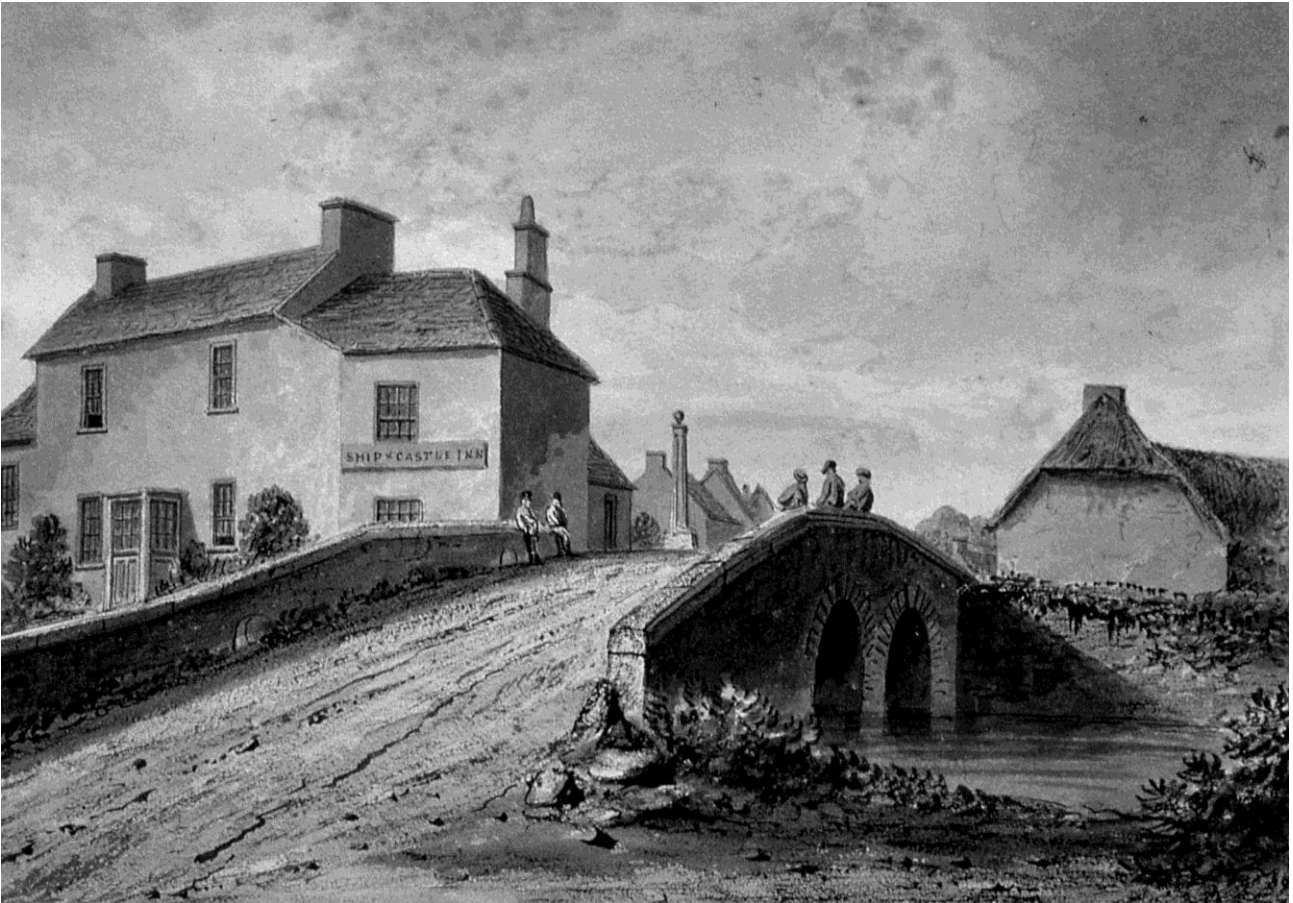
Fig 7: The view over Congresbury's medieval bridge (removed 1928) to the village cross, standing at the cross-roads (Piggott collection)

The cross is first drawn in the 1820's when it was in the middle of the cross-roads where Broad Street and High Street met the Weston-Bristol road.

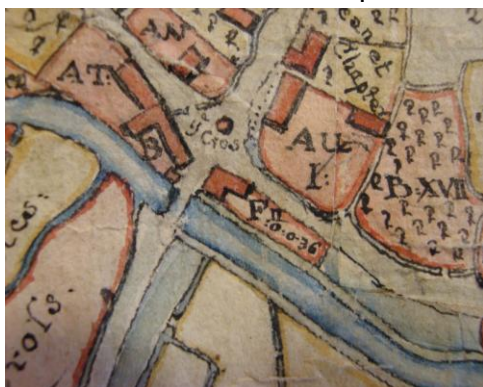
Fig 8: Map of Congresbury village (late 18th century) showing site of the cross at the village centre. Note the stream crossing High Street by the cross and running along Broad Street

The site of the cross was also recorded in one of the earliest maps of the village, a copy of the de Wilstar 1736-9 manorial maps.

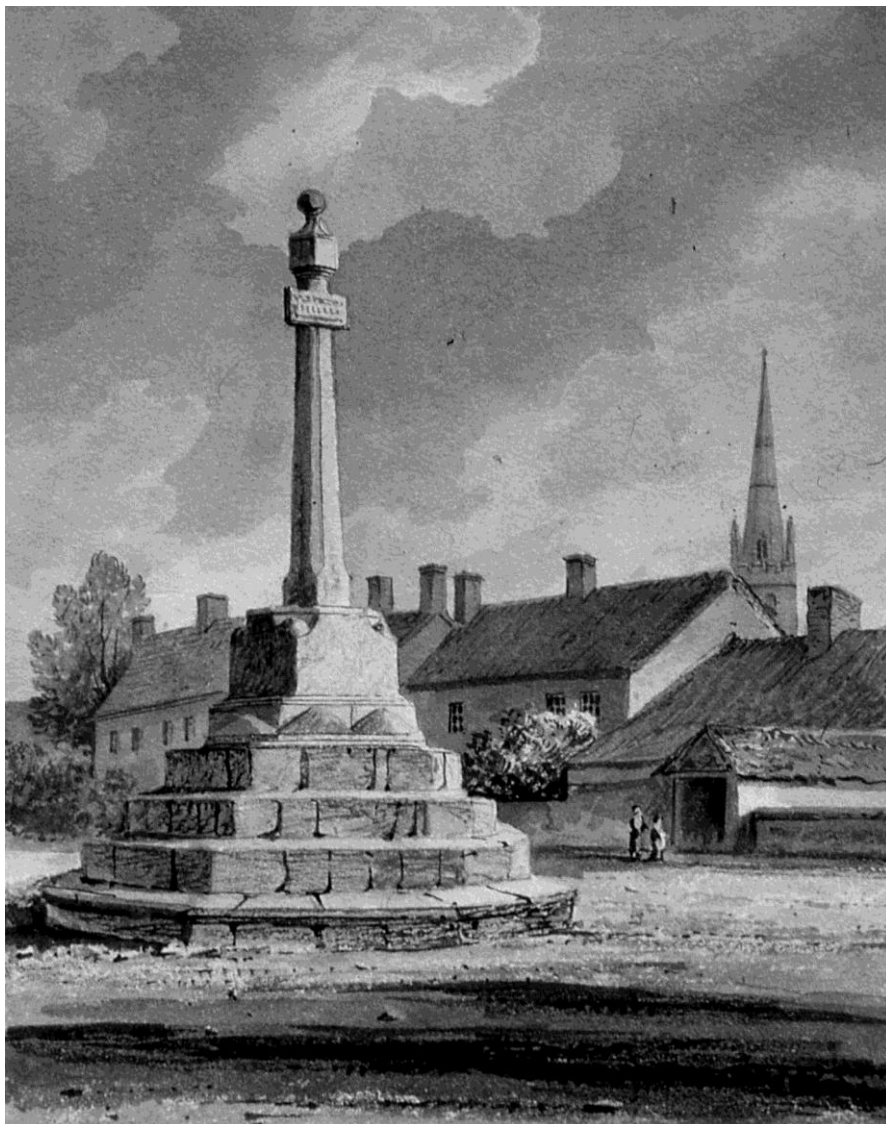
Fig 9: Congresbury village cross in 1827 (Piggott collection)

The Piggott collection also contains the earliest known detailed depiction of the cross (Fig 9 above). While the depiction of the 'star-plinth' (see below) is unsure, the basic details of the cross (including that it had just four steps) are clear. If there had been another two steps, as Pooley says, they would surely have been visible in this pre-metalled road times. The nature of the affix at the top of the shaft is not clear from the drawing, but it appears to bear two lines of text – 'CONGRESBURY / MARKET' perhaps?

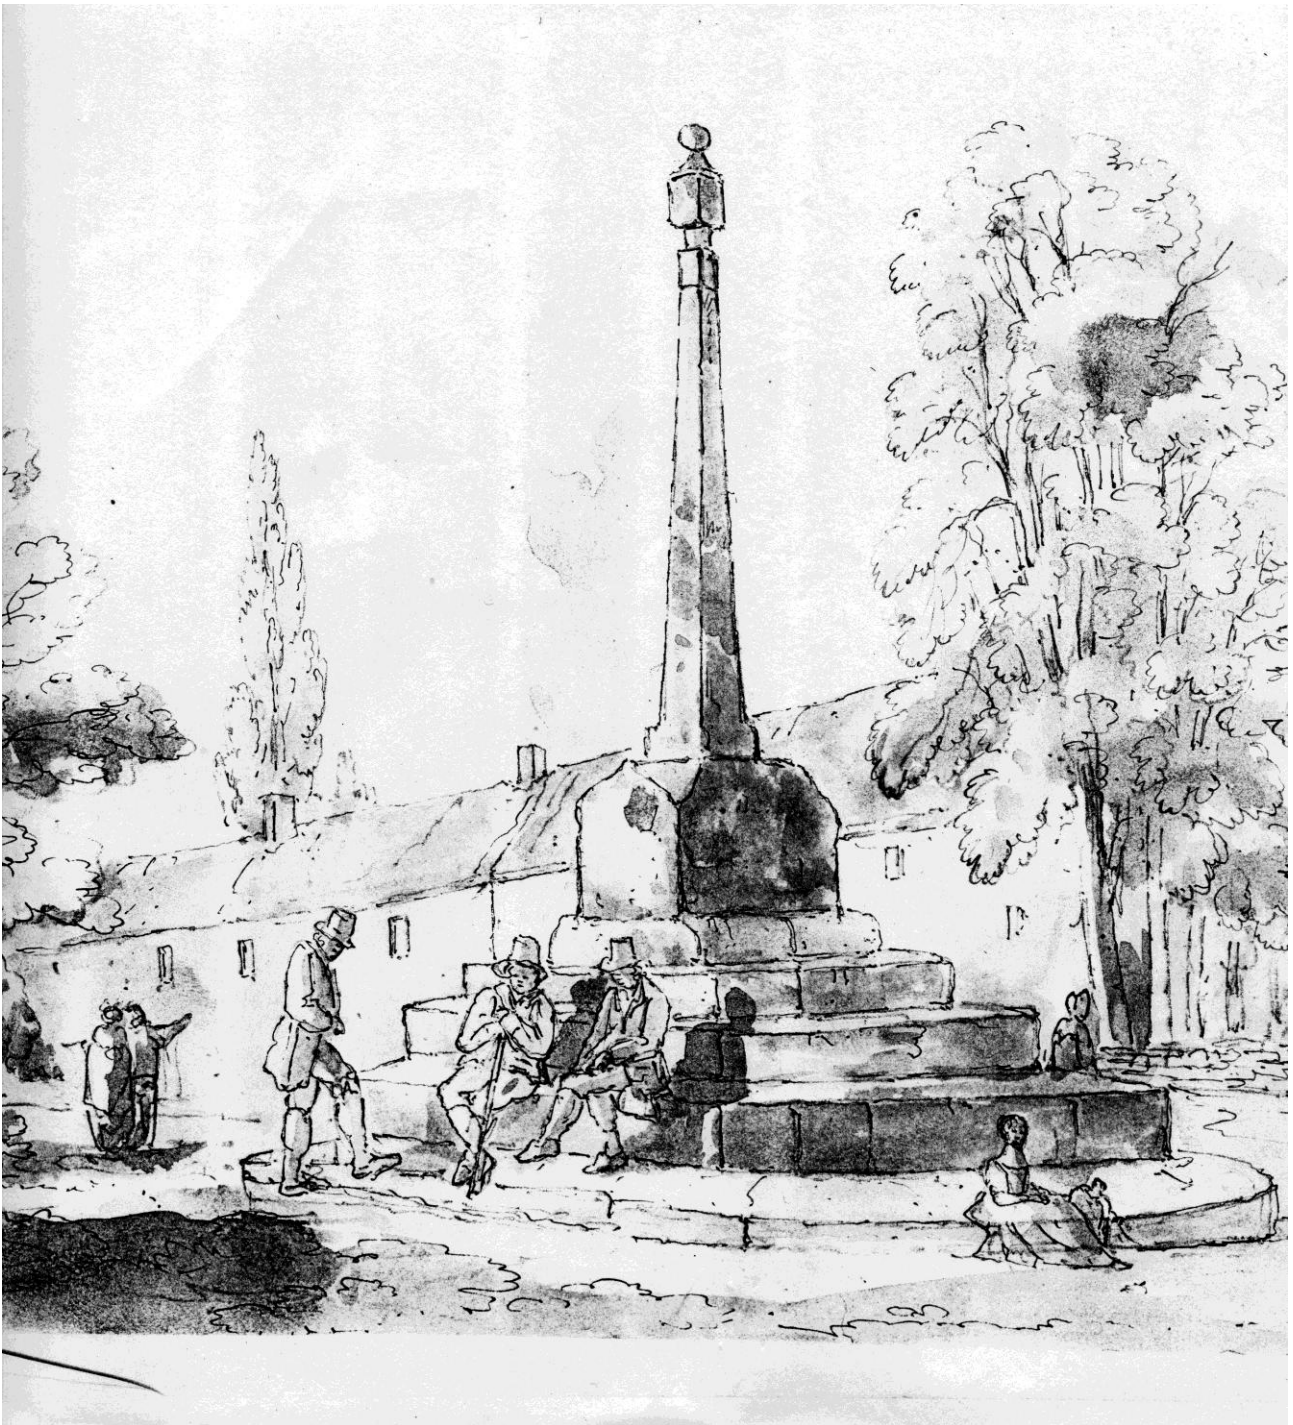
The next depiction of the cross was in the 1840s, by Braikenridge (Fig 10 below). While the scale of the cross is rather exaggerated (the human figures are reduced to not much more than a metre tall – hobbits in Congresbury, any one?) - the business and usage of the cross as a place to sit and gossip is probably very apt. The female figure at the lower right seems to have a bag with her: is this a depiction of something being sold at the cross?

Fig 10: Congresbury village cross in c1840 (Braikenridge collection)

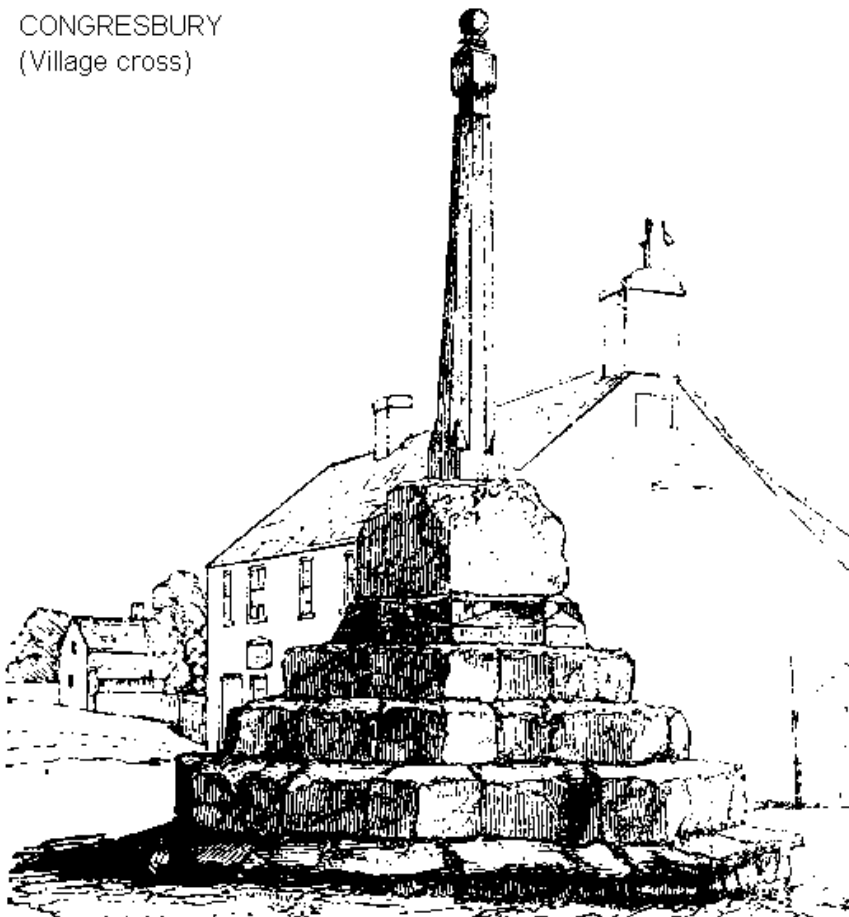
CONGRESBURY
(Village cross)

The Village Cross is a structure of later date - fifteenth century, and is in a fair state of preservation. Its plan is octagonal. The Calvary consists of four steps -formerly six - two being buried by the raising of the roadway. The present basement is benched, and has a deep drip. The socket is of very large dimensions, proportioned to its original lofty elevation. Its square base is worked to an upper octagon by high-shouldered convex broaches at the angles.

It rests on a plinth of a character not unlike that of Yatton, being octagonal and splayed, with its angles obliquely chamfered to bold projecting nosings. The shaft is a tall tapering monolith,

capped by a modern square block of stone with a ball on the top. It is mortised with lead into the socket.

Fig 11: The village cross in 1870s
(Pooley 1877: page)

Pooley is the first illustrator to produce a recognisable background: the Ship and Castle Inn opposite looks realistic enough to be identifiable.

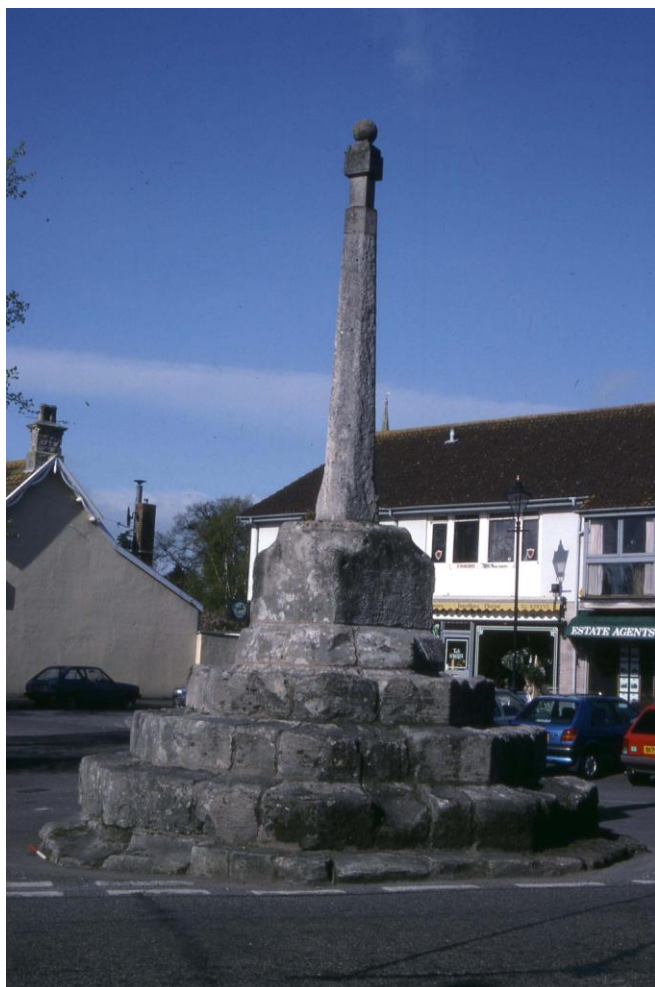
Fig 12: Village cross in 1994 (Vince Russett)

Although road resurfacing has crept up the lowest step, the cross is in otherwise good condition, and sometimes over-eager schemes to 'restore' the cross have by and large been resisted. This cross, a Scheduled Monument (Avon 111), formerly belonged to the Charity Trustees of Bristol Corporation as Lords of the Manor, but was handed back to the parish in the early 1970s. It is well preserved, but the story that there are two further steps below the road surface seem not to be based on any hard evidence. Six steps would be very unusual for a stone cross in Somerset. The deep drip on the lowest step that Pooley mentions was almost entirely gone by 1973, although its last traces could just be seen: they are now covered by subsequent tarmac. Its former existence is a powerful argument for there only ever having been four steps: certainly, only four are shown on Braikenridges drawing of c1840-50 (Fig 10 above).

As Pooley noted, the socket rests on a Dundry / Wraxall type plinth, and although this is very worn, there do not appear to be any broken out-dowels in the points, unlike Dundry. The shaft is as portrayed by Pooley, with one small drill-hole about 0.8m above the stops. The dial cube does not appear to have any fixings for a sundial, and may be purely decorative.

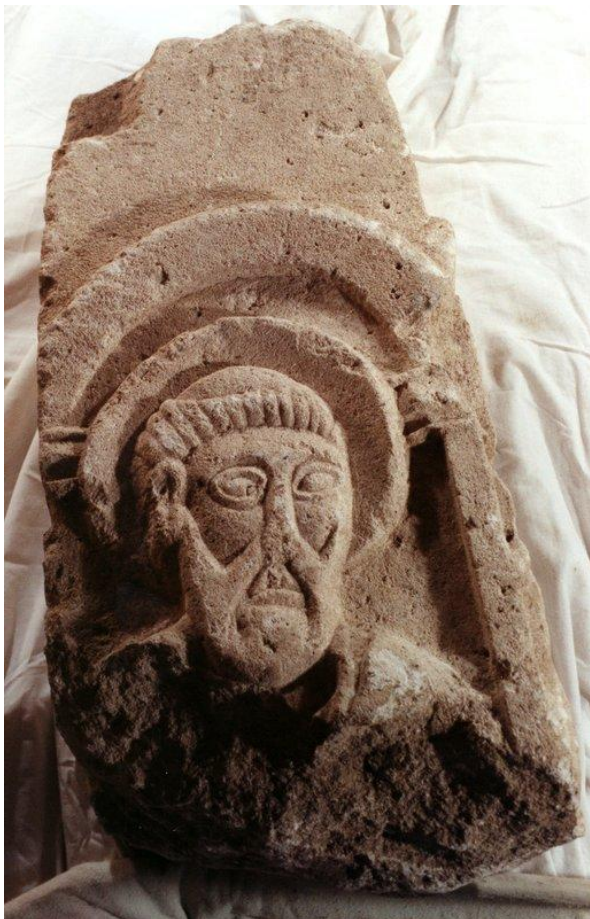
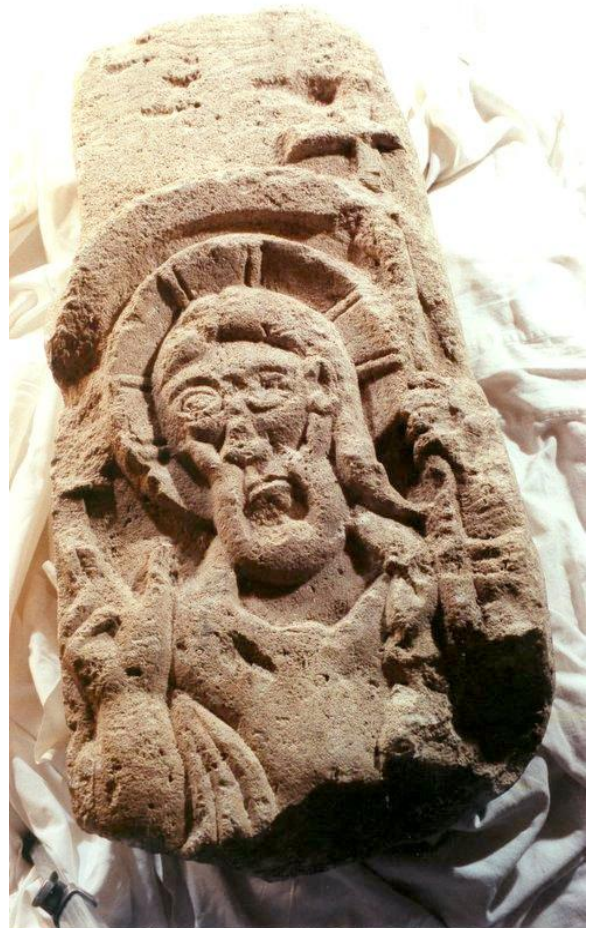
It is apposite to include here a brief note on the very high-quality pre-Conquest carved stones found in 1995 in the foundations of a building under conversion in Brinsea Road, Congresbury. These striking late saxon carvings (see below) were at the time interpreted as being parts of a Saxon cross.

Fig 13: Two of the Brinsea Road stones (Mike Bedingfield)

They are now believed to be portions from a shrine to St Congar, that formerly stood in the parish church of St Andrew. (Oakes and Costen 2003).
