YCCCART 2022/Y9

St Mary the Virgin church, Yatton

Part 4. Outside the church

**YATTON, CONGRESBURY, CLAVERHAM AND CLEEVE
ARCHAEOLOGICAL RESEARCH TEAM (YCCCART)**

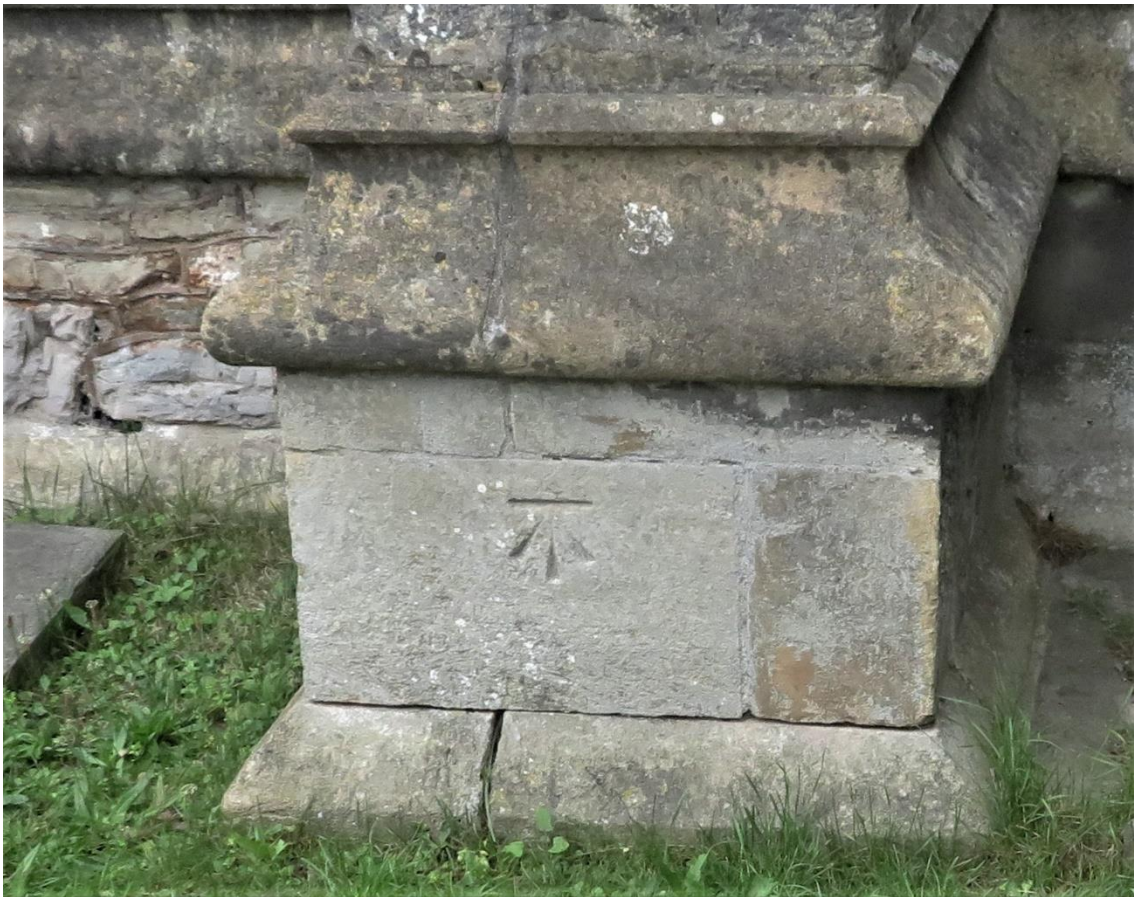
Fig 4: Ordnance benchmark.

On the eastern end of the south side is this Ordnance bench mark which indicates the height above sea level. In this case 13.426 meters.

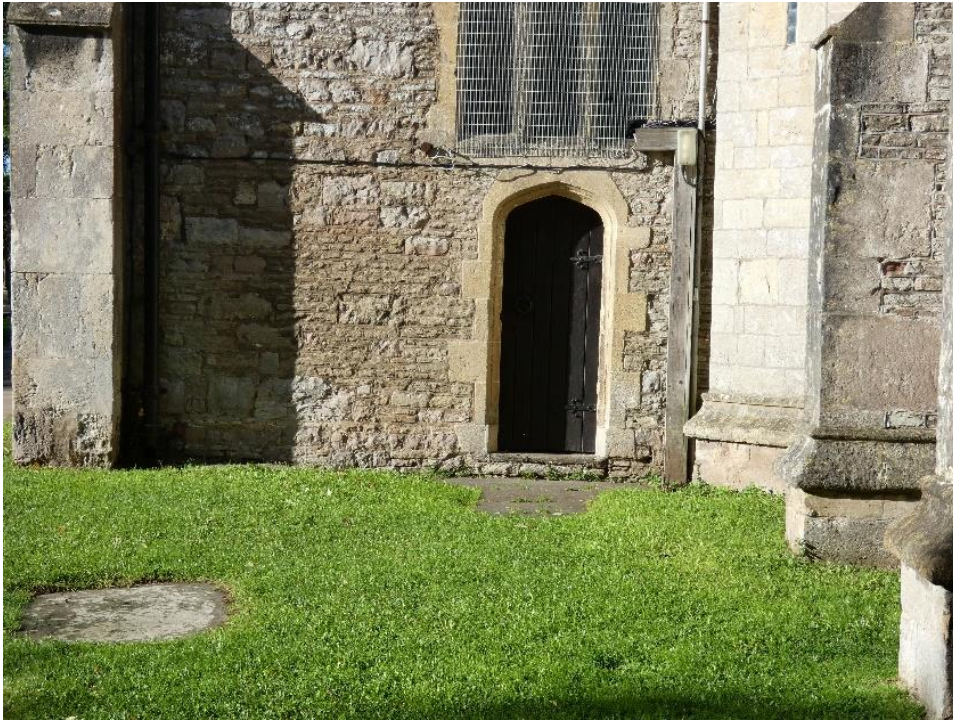
Fig 8: Doorway on east side of the vestry.

The doorway on the left originally gave entry to the Chapel of St Thomas (now the vestry). The doorway enabled the priests to enter the vestry without going through the nave.

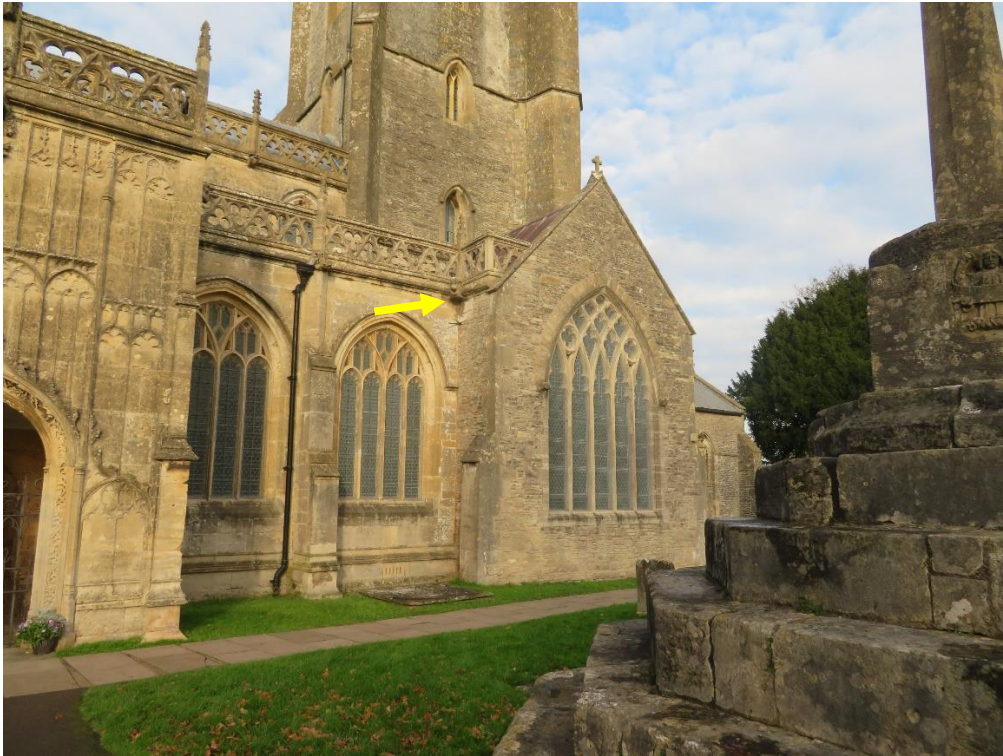
Fig 12: Location of gargoyle indicated by arrow.

The yellow arrow above (Fig12) shows the location of a gargoyle.

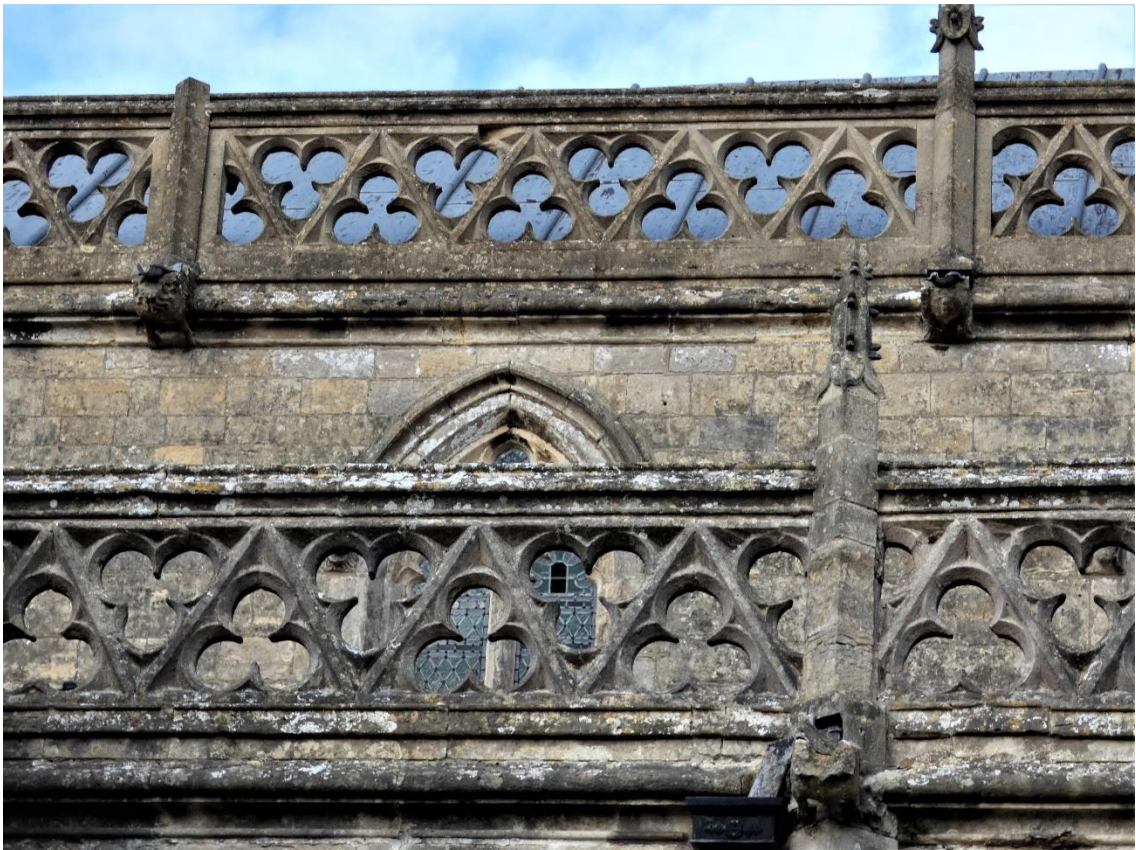
Fig 15: Close up view of parapets right of the south porch.

Below both parapets to the right of the south porch are the remains of three gargoyles. See Figs 16 to 18 below.

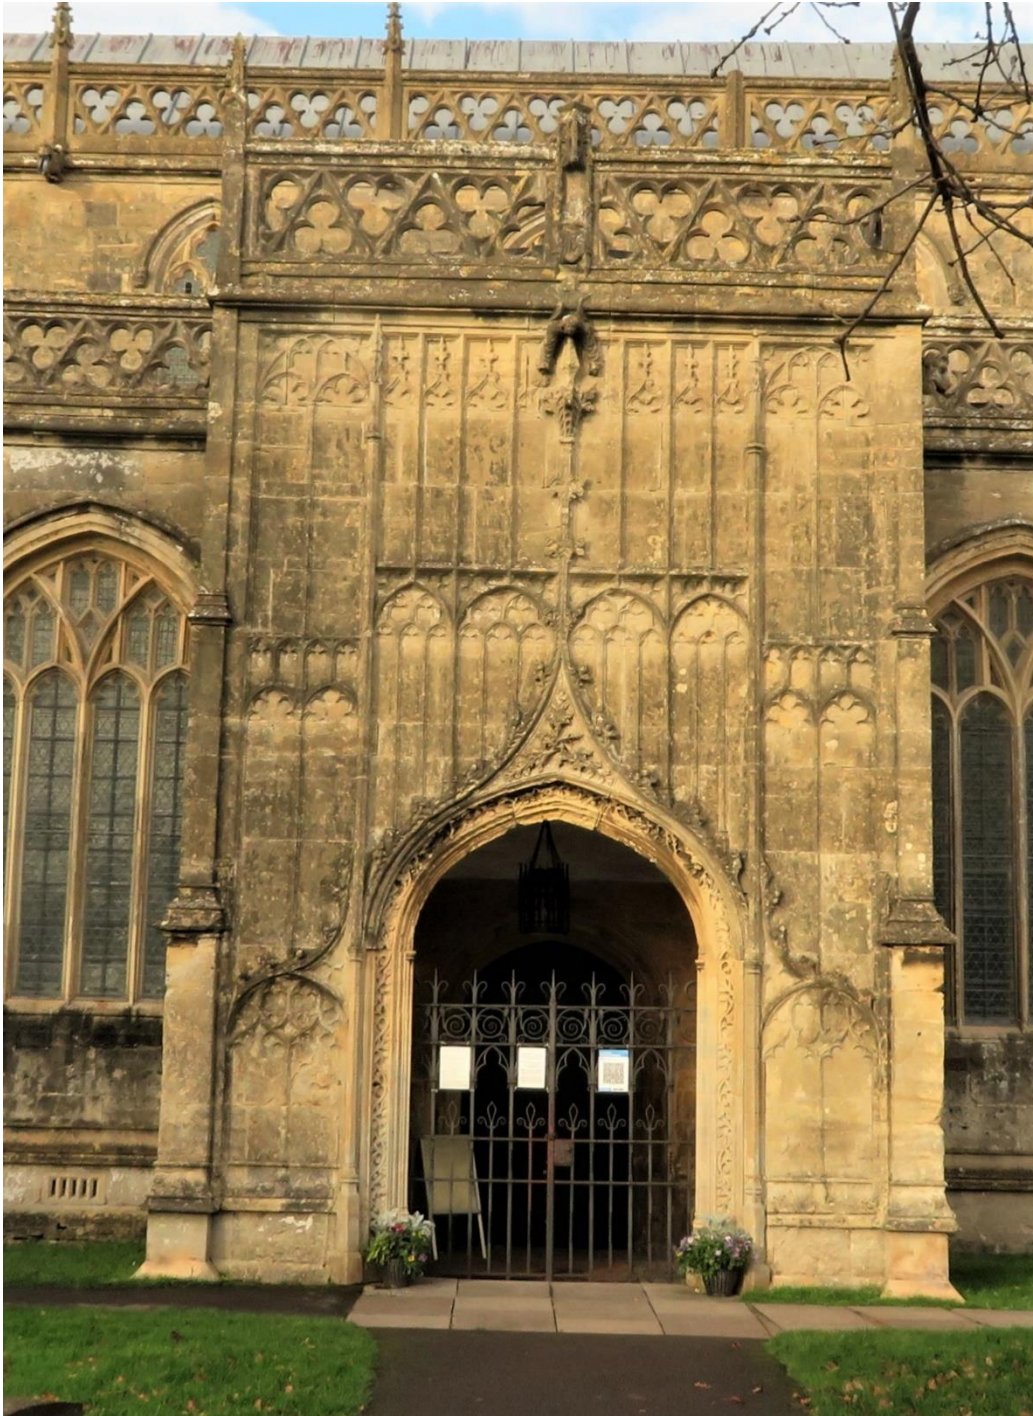
Fig 19: South porch.

The magnificent 15th century south porch is the most highly decorated in Somerset.

It has two storeys.

The arched entrance has a frieze of small leaves running up the jambs (lining of doorway) and along the arch.

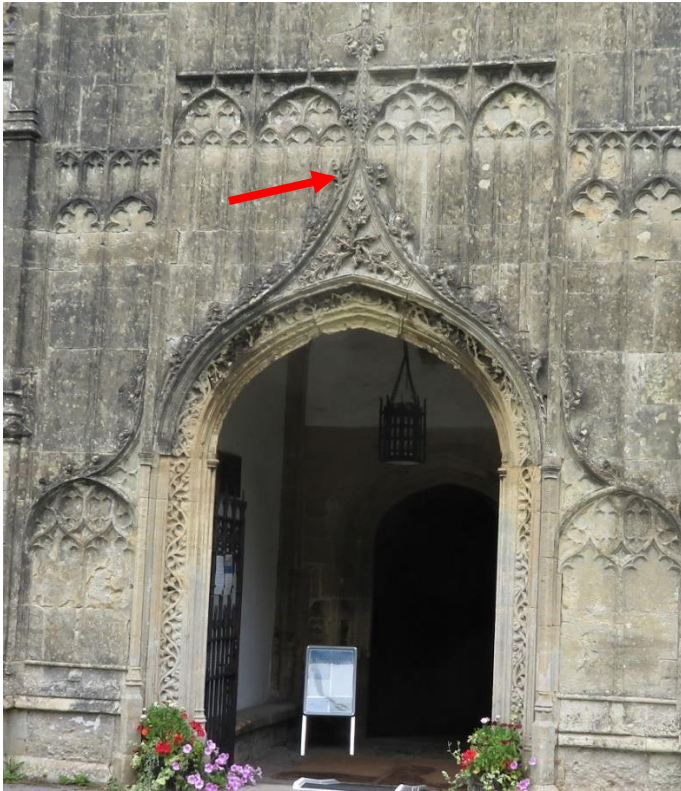
Fig 20: Close up of doorway.

The ogee gable, indicated by the red arrow, has more foliage and naturalistic crockets (small, sharply projecting medieval ornaments decorated with foliage).

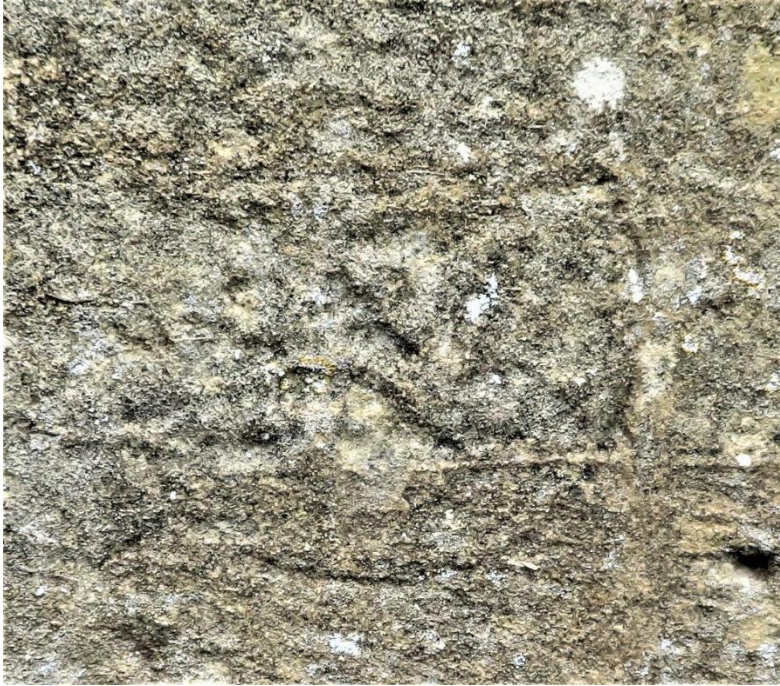
Fig 22. Circular feature on the right hand panel.

The right panel contains this circular feature, in Fig 22, which is about 10 cm (4 inches) in diameter.

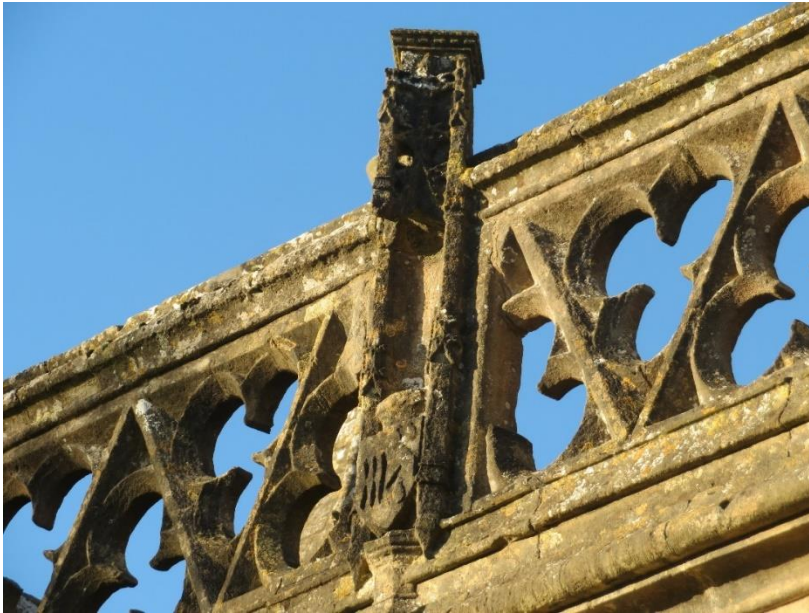
Fig 23: Parapet above porch.

The parapet above the porch has a niche which once held a statue. Only the shield remains.

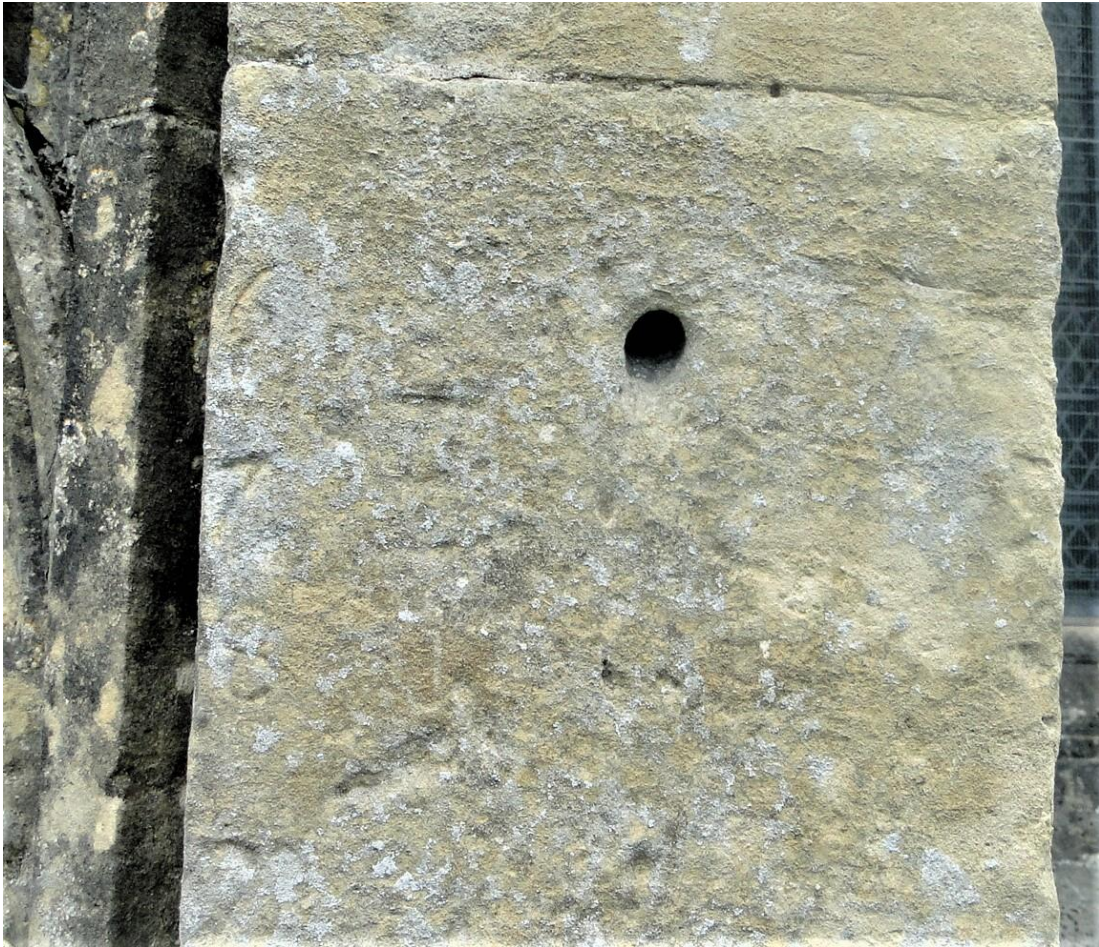
Fig 26: Mass dial right of the porch entrance.

On the right of the porch entrance are the remains of a Mass dial. You can still see the numbers 6, 7, 8 and 9 on the left and the central hole (gnomon) in Fig 26 above. The numbers suggest this is probably a late mass dial, perhaps contemporary with the porch.

By placing a stick in the hole the priest would indicate there would be a Mass by the shadow reaching the next number. The number would vary according to the season.

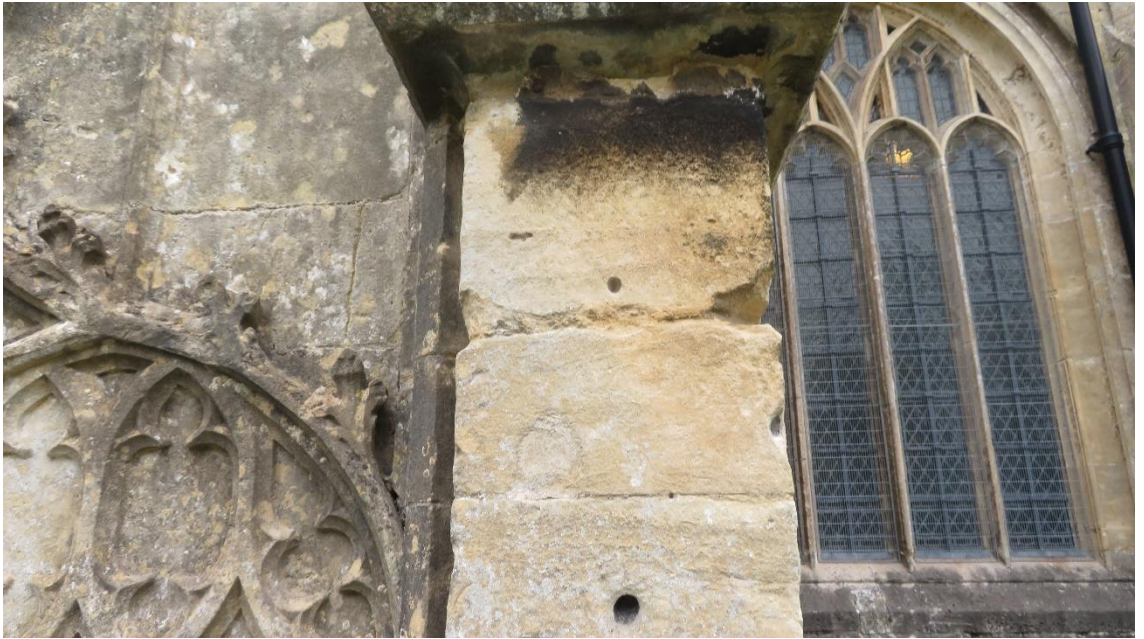
Fig 27: Above the Mass dial at Fig 26 is another smaller hole and possible Mass dial.

A small circular feature to the upper right in Fig 27 is possibly an abandoned mass dial.

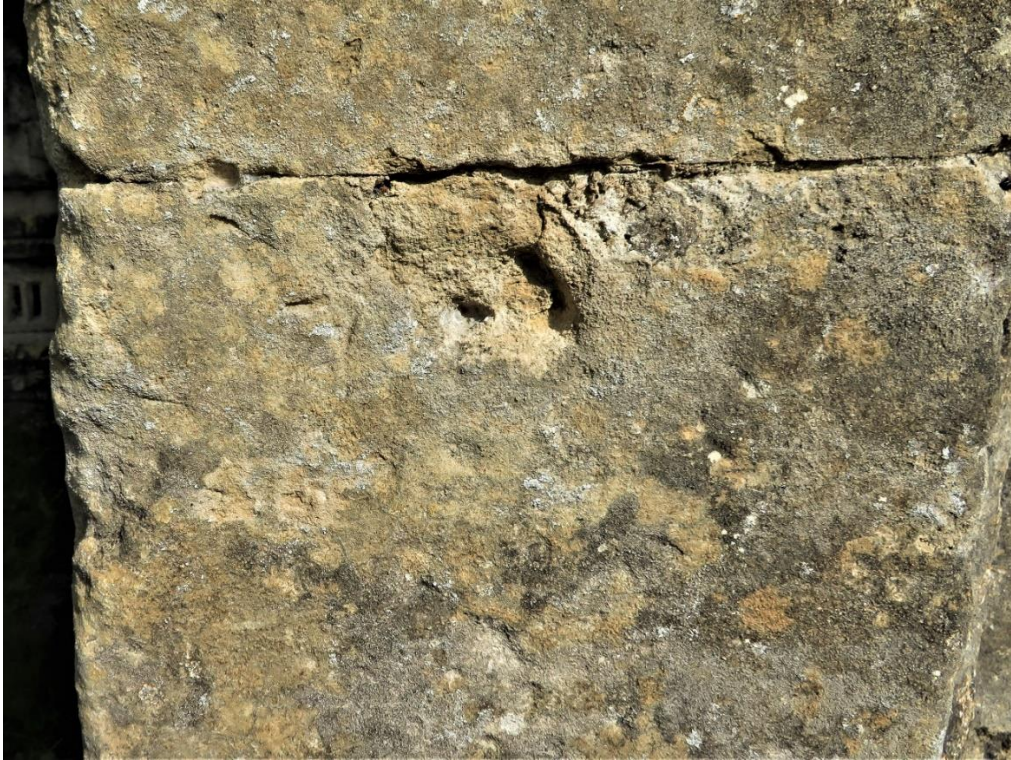
Fig 29: Circular feature left hand side of porch.

On the left-hand side of porch is this circular feature. Another abandoned mass dial?

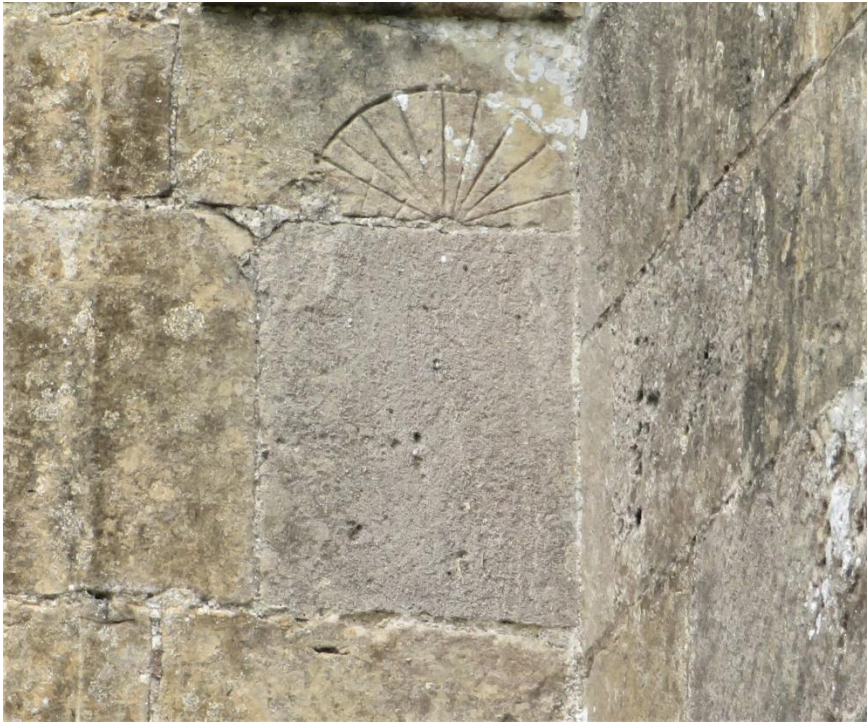
Fig 38: Upside down Mass dial.

On the south wall adjoining the porch on the western side is the remains of a possible mass or scratch dial. It has been incorporated upside down (See middle top in Fig 38).

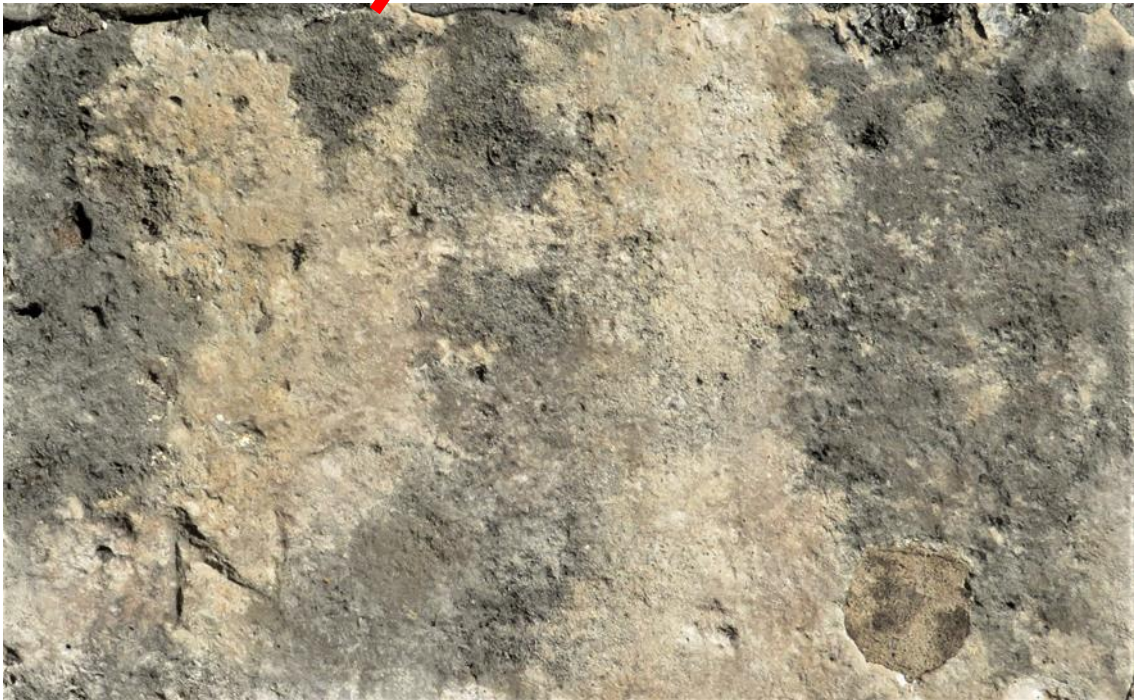
Fig 40: Letters on the south wall, east of the south porch.

East of the south porch on the south wall is the letter N. and an 'O', then to the right possibly an R or B.

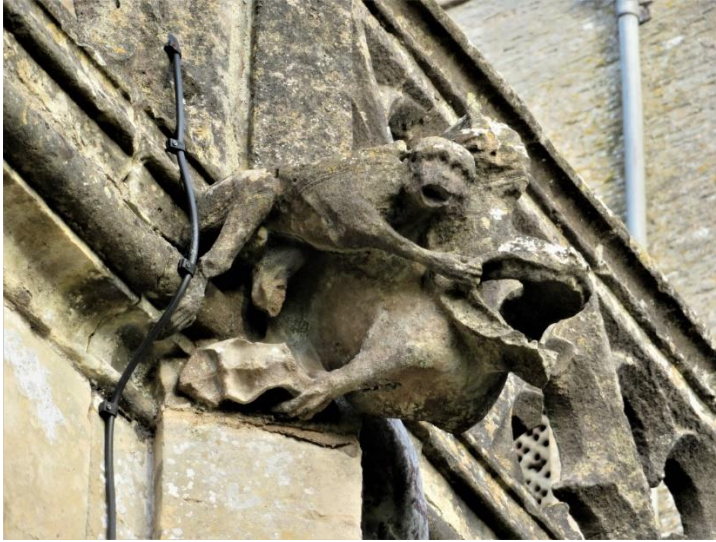
Fig 41: Ape & toad east of the porch.

Above the windows east of the porch, is an ape holding open the mouth of a toad, shown in Figs 41 and 42.

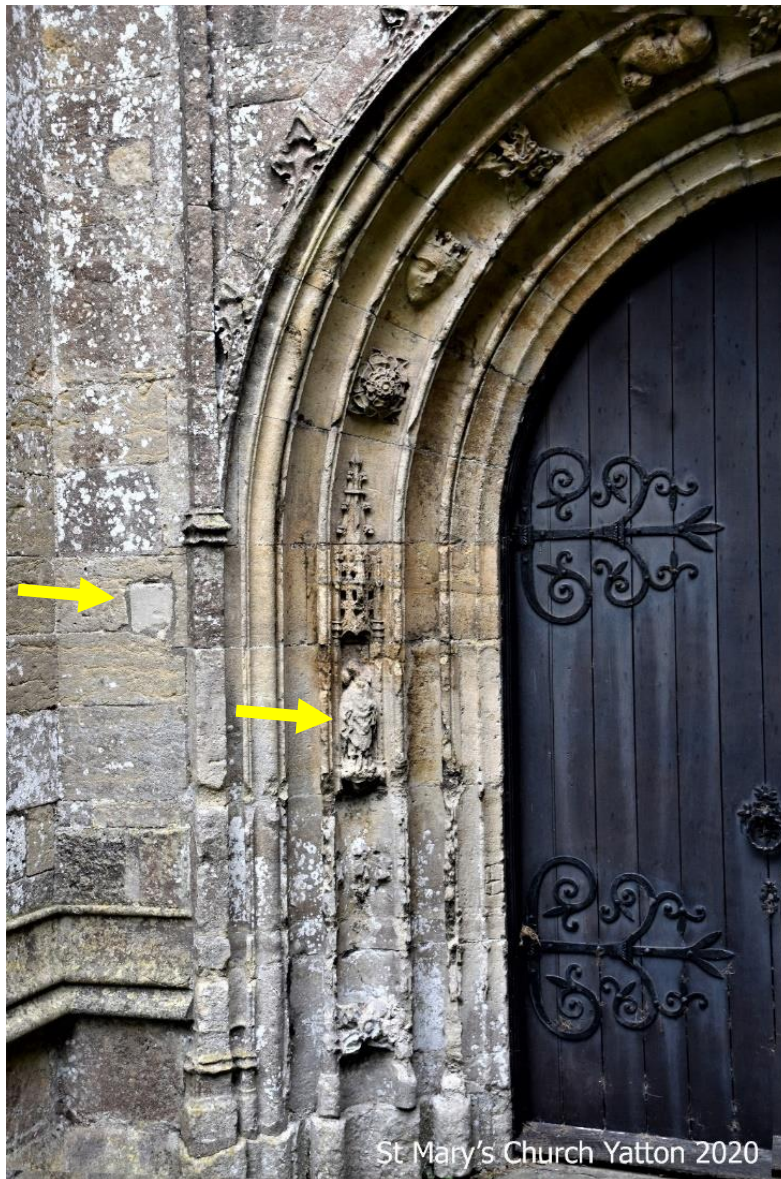
Fig 55: Left of the west end door.

Left side of doorway. Note the headless statue (lower arrow on Fig 55) and that the lower parts of the doorway are weather worn. It has been suggested that the two square in-filled blocks about 1.5m above the floor and at the same height either side of the doorway (see upper arrow on Fig 55), may suggest there was once an outer, perhaps wooden, door.

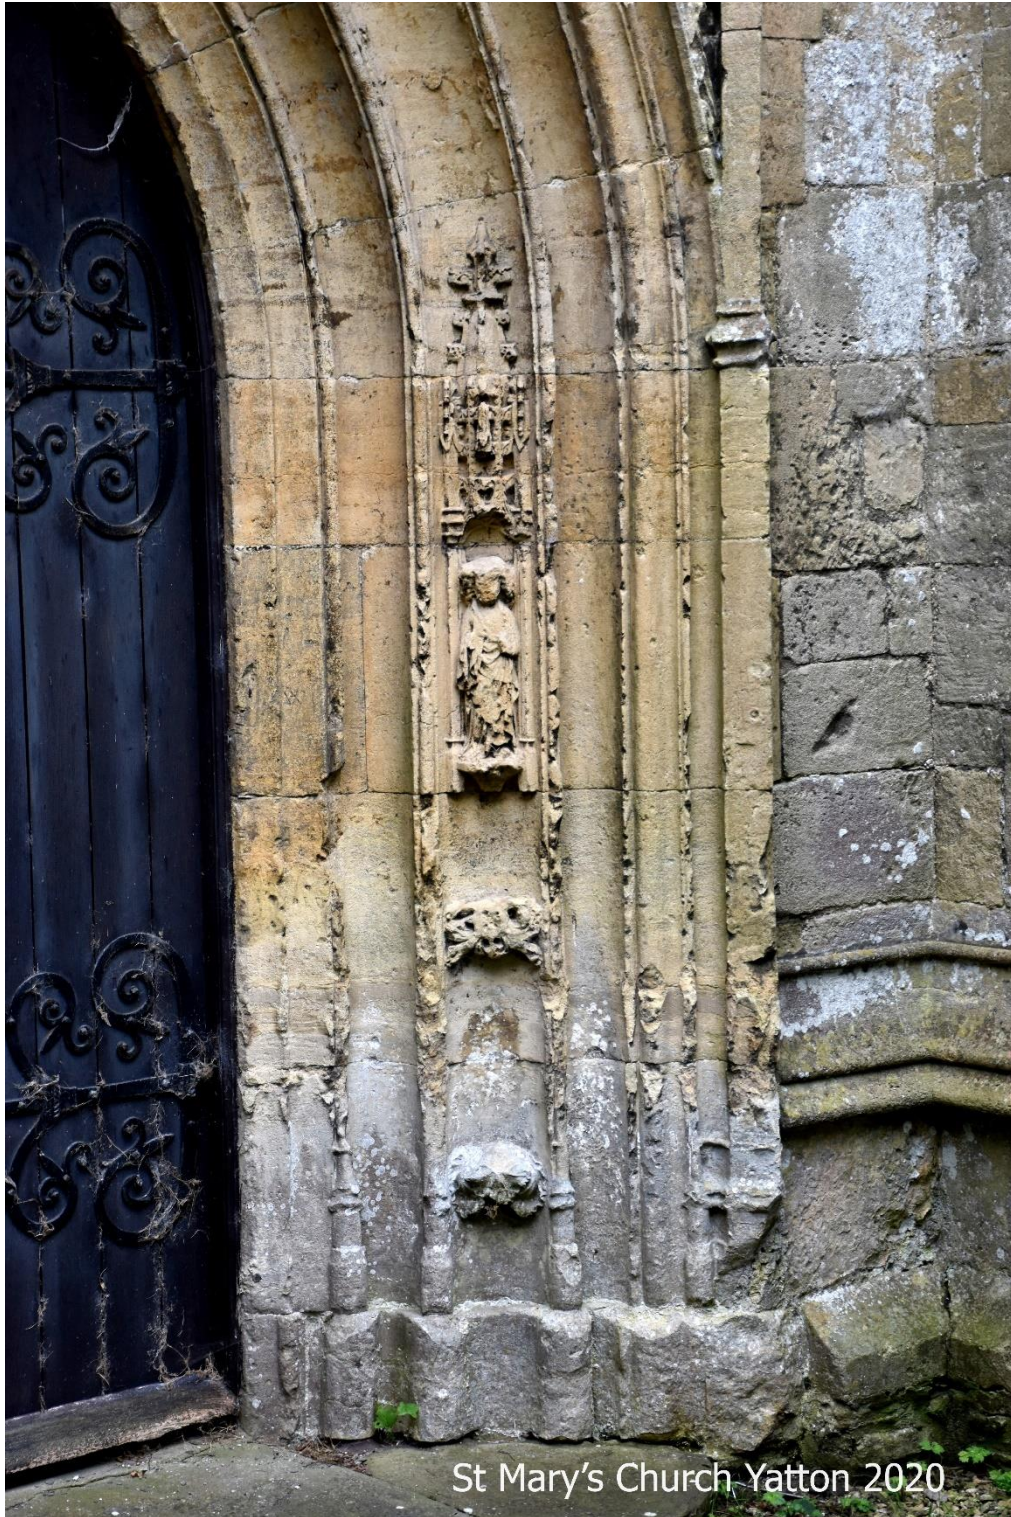
Fig 56: Right hand side of doorway.

Right hand side of the doorway (Fig 56 above). This statue has survived.

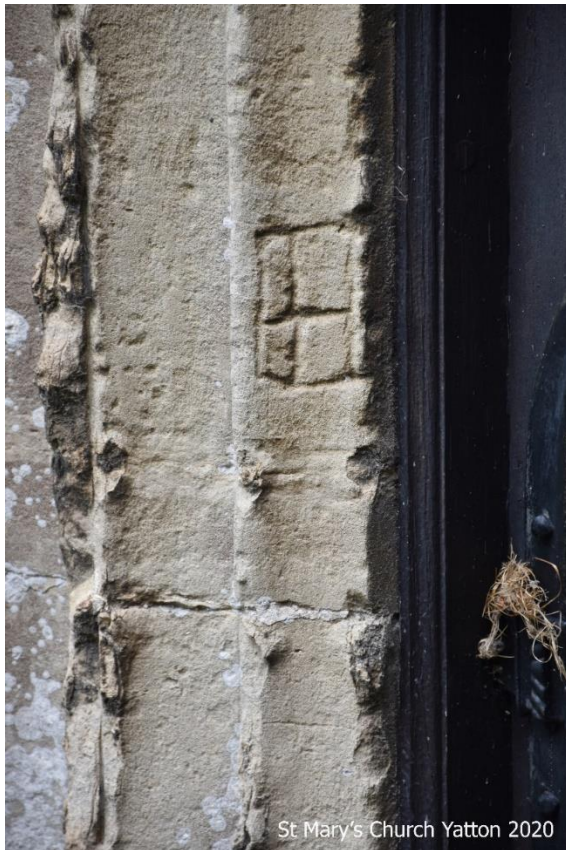
Fig 59. The left-hand arch has graffiti towards top.

The graffiti on the left-hand side of the door (Fig 59 above) is identical to that on the left-hand side of the north door as shown below (Fig 60).

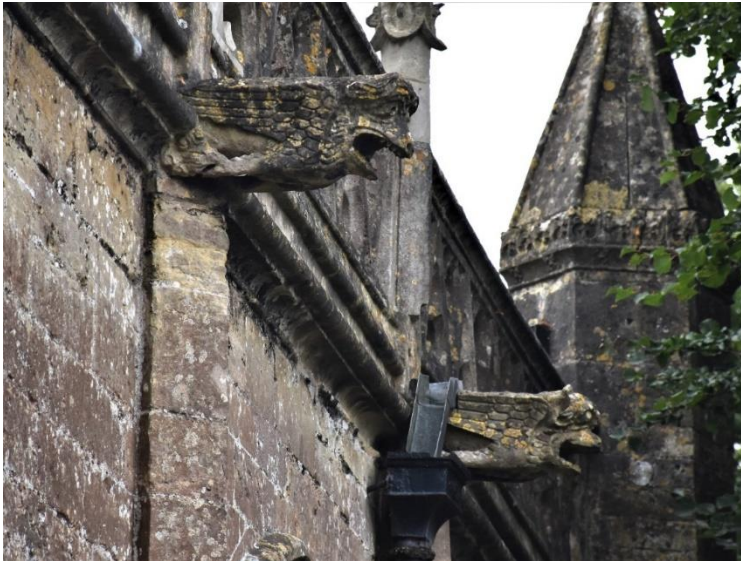
Fig 67: Gargoyles above the Chapter House corridor.

These gargoyles are partly obscured by the corridor of the modern Chapter House.

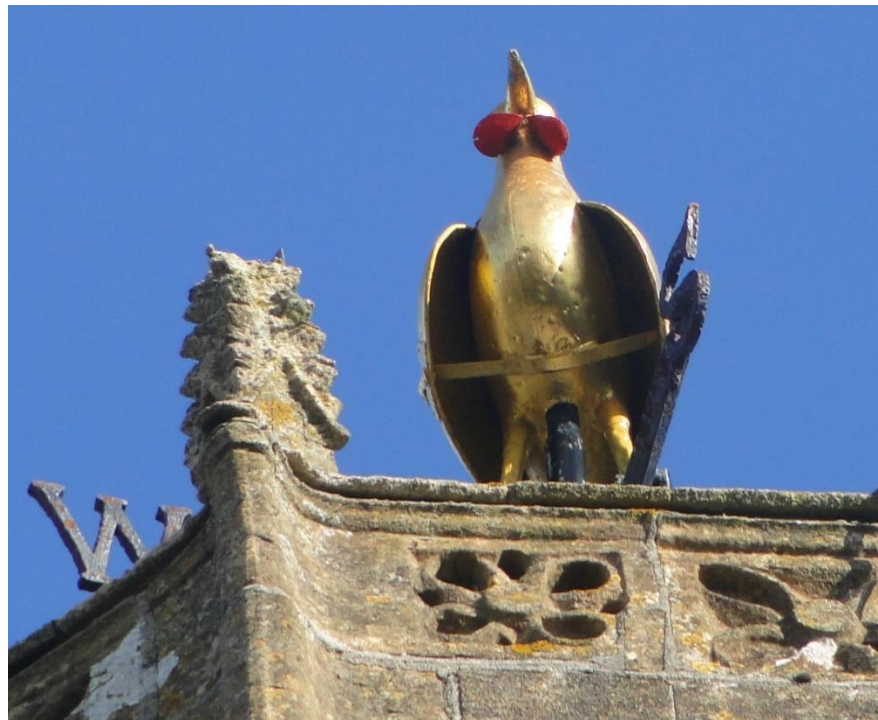
Fig 81: Front of the weather cock on a sunny day.

The weather cock dates to 1822, according to the Heritage Listing.
